ADEQ Hazardous Waste Division Technical Branch Trip Report

Project	Cedar Chemical Site
Location	Helena-West Helena
Date	4/27/2012
Time	1100 to 1136 hours
Reason	Monthly Site Visit
ADEQ personnel	Annette Cusher Jim Rigg
Facility, contractor and EPA personnel	Mr. Harrington
Activity Summary	<p>Jim and I were met upon arrival at the site by Mr. Harrington. The following issues were discussed during the walk through.</p> <ul style="list-style-type: none"> • A pole was removed cracking the asphalt while demolishing a shed. The remaining poles were cut off at the level of the asphalt. • The old lab building is collecting water after rain events and has become moldy. Harcross would like to demolish the building. • The waste from the renovation of the sump is still covered on a slab. Mr. Harrington indicated Harcross was in contact with Clean Harbors for disposal. • Mr. Harrington also indicated that Harcross would be running underground utilities when they begin to utilize the unused unit. • There are several five gallon buckets of what appears to be purge water (buckets are labeled with monitoring well numbers) still on-site. Harcross would like to know what should be done with the cont

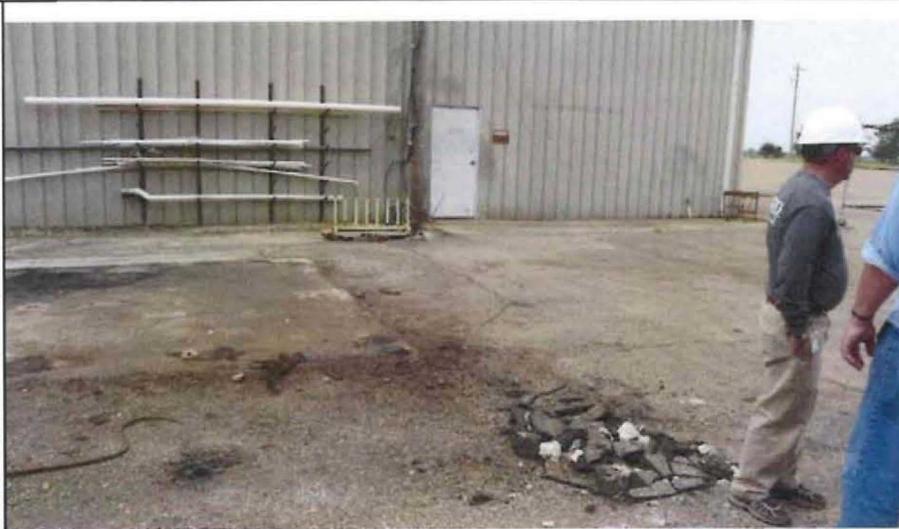
Location:	Cedar Chemical Site							
Photographer:	A. Cusher				Witness:	J. Rigg		
Photo #	1	Of	6		Date:	4/27/2012	Time:	
Description:	Cracked asphalt from pole removal

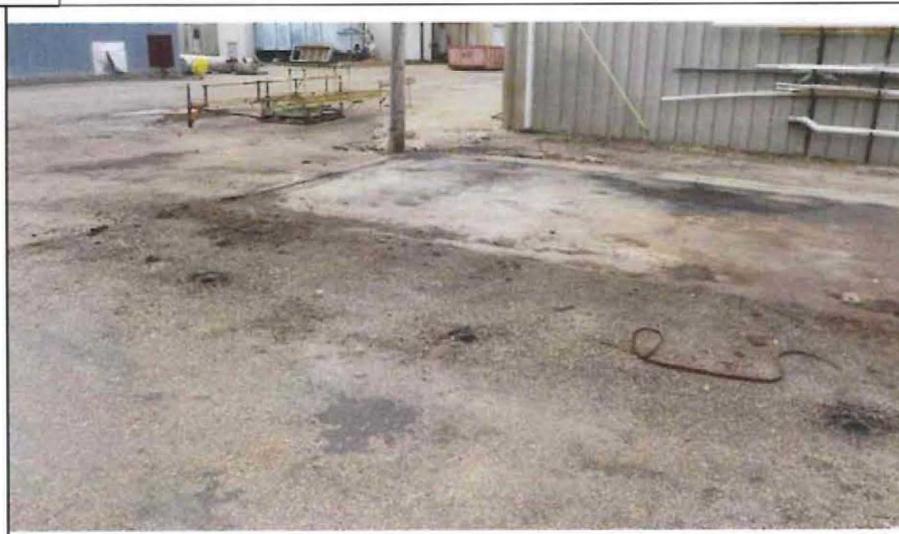
Photographer:	A. Cusher				Witness:	J. Rigg		
Photo #	2	Of	6		Date:	4/27/2012	Time:	
Description:	Area where poles were cut off at asphalt level

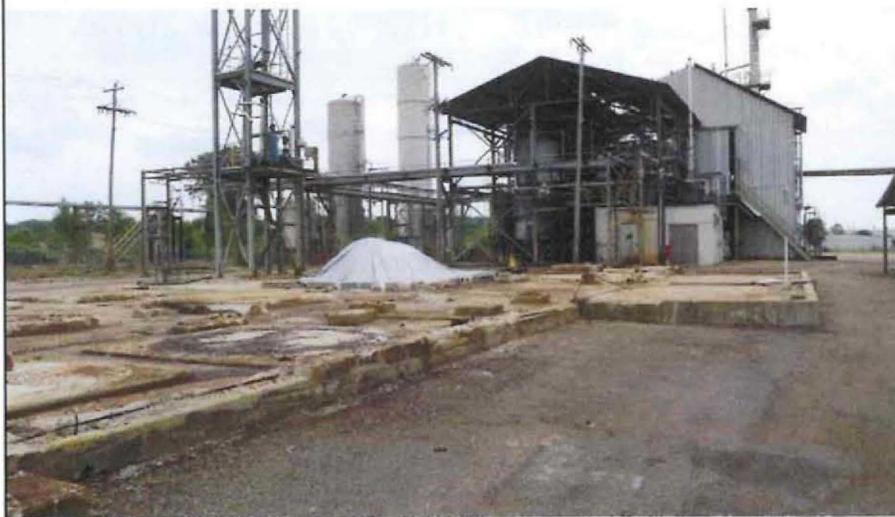
Location:	Cedar Chemical Site						
Photographer:	A. Cusher			Witness:	J. Rigg		
Photo #	3	Of	6	Date:	4/27/2012	Time:	
Description:	Covered waste pile

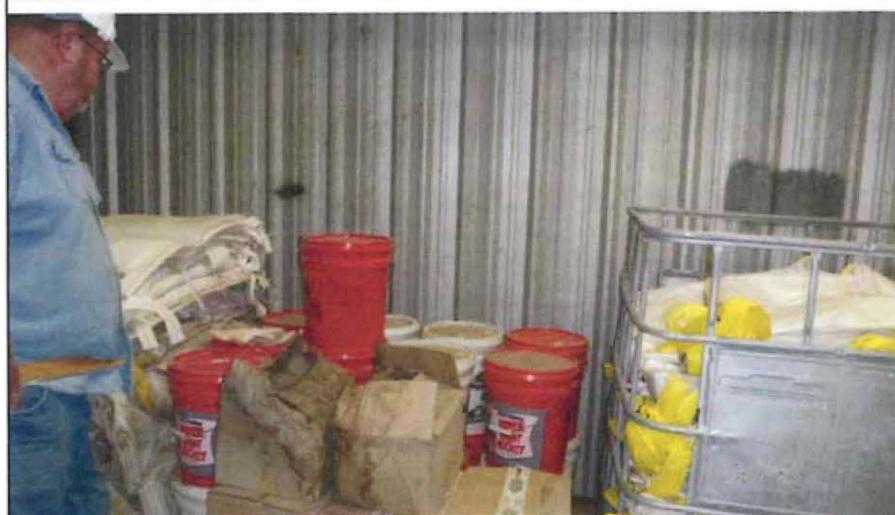
Photographer:	A. Cusher			Witness:	J. Rigg		
Photo #	4	Of	6	Date:	4/27/2012	Time:	
Description:	5 gallon containers of purge water

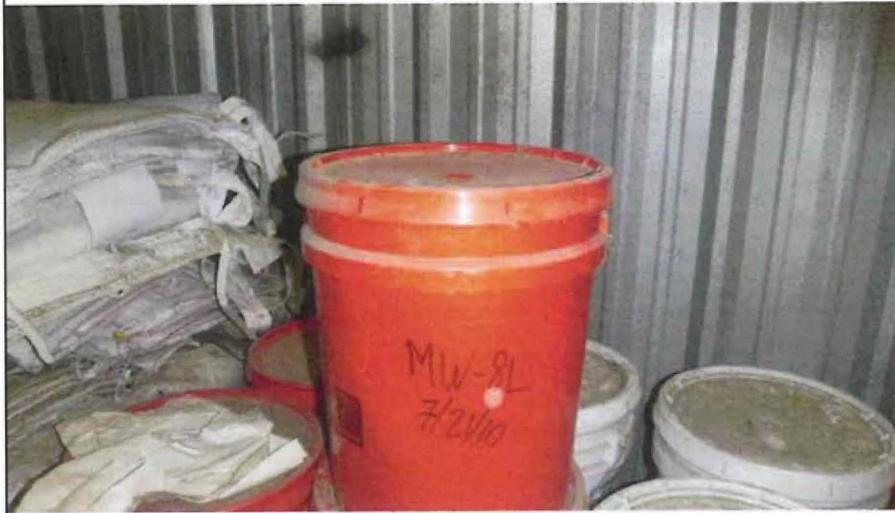
Location:	Cedar Chemical Site					
Photographer:	A. Cusher			Witness:	J. Rigg	
Photo #	5	Of	6	Date:	4/27/2012	Time:
Description:	Close up of 5 gallon container label

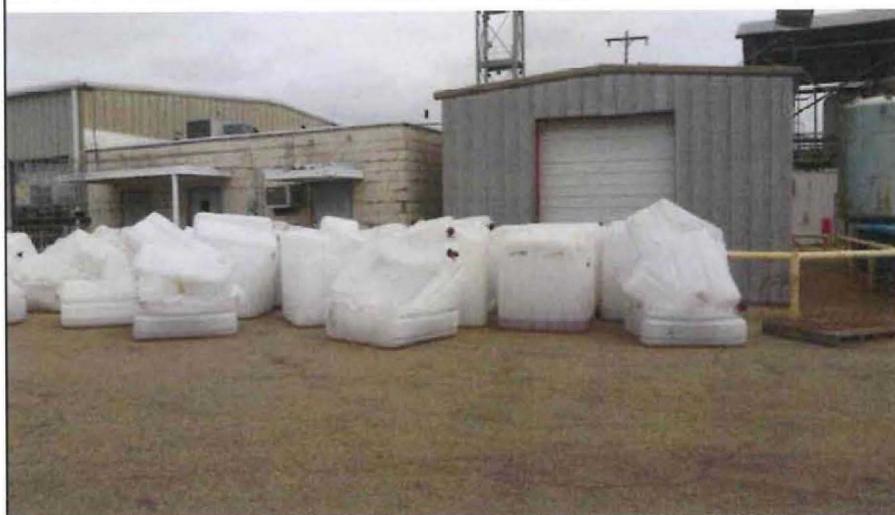
Photographer:	A. Cusher			Witness:	J. Rigg	
Photo #	6	Of	6	Date:	4/27/2012	Time:
Description:	Damaged empty containers
